THE CRUCK-FRAMED BARN AT SEDDONS FOLD, PRESTOLEE

V Tanner

INTRODUCTION

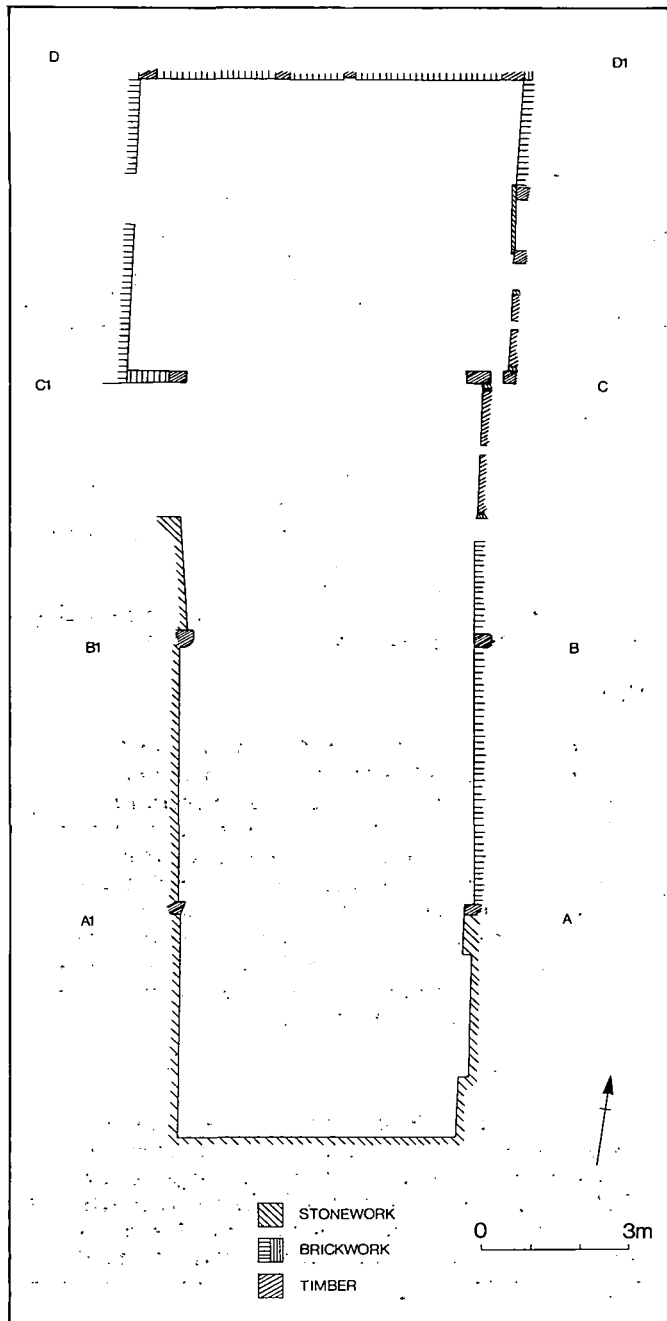
Fig 1 Seddons Fold : ground plan

The barn is a cruck-framed building, in which the weight of the roof is carried by a series of transverse trusses, formed by pairs of massive cruck blades. They are full crucks, with the timbers rising from ground level to the apex of the roof. Each truss is also strengthened by cross-beams connecting the two blades (Ryder 1979, 6). These occur in various positions at Seddons Fold: below the apex of the timbers at roof level (the collar-beam); where the cruck trusses are connected by longitudinal timbers supporting the rafters (the purlin-beam); where a transverse beam meets the wall level (the wall tie-beam); and at ground level as a lower cross-beam. The transverse cross-beams are all set into the cruck blades, and up to four pegs are used to secure the half-lap joints. In almost every case the pegs have been inserted in a different direction, and are located randomly so as not to split the beam (Charles 1981, 25). The trusses divide the area within the barn into four bays of approximately equal length (Fig 1).

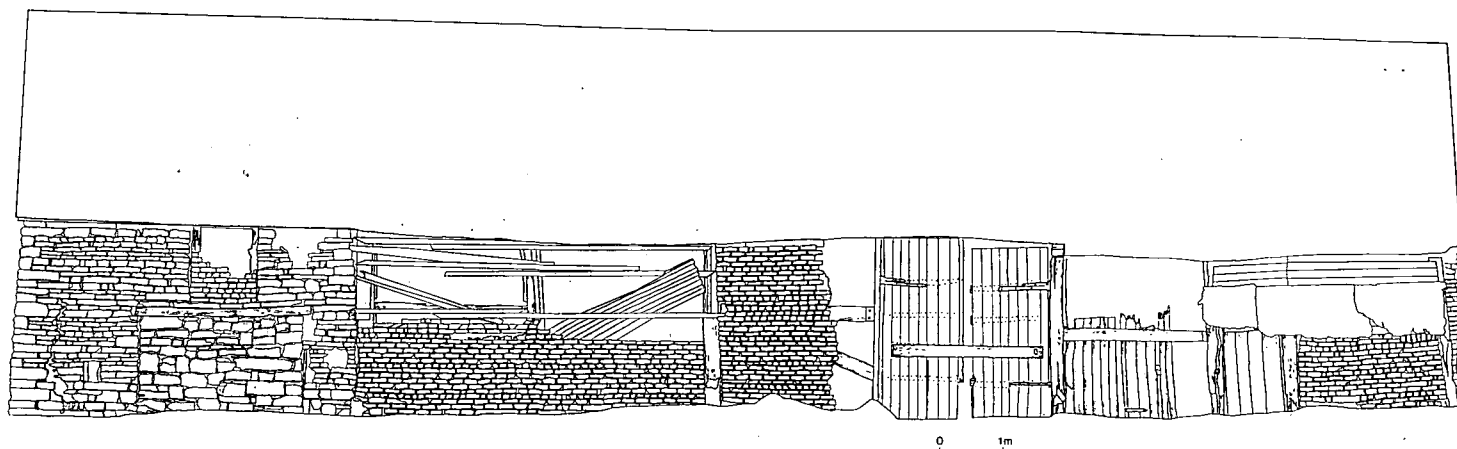
Fig 3 Seddons Fold : east elevation

This bay is constructed almost entirely from sandstone but appears to be integral to the whole structure, since the overlapping scarf-joints on the purlins could only be placed in position if this were the case. The entrance through the eastern wall has been altered on a number of occasions (Fig 3): the lower doorway having been infilled with stonework, possibly at an early date, and the upper entrance blocked by brickwork. It was doubtless this bay which was used for the storage of farm produce, since the upper doorway must have provided access to an upper floor or loft. Several vents in the southern wall of the barn (Fig 4) would have assisted in the circulation of air around the stored grain. Part of the western wall is constructed of brick, in a mixture of English and Flemish bond (Brunskill 1978, 46), and is similar in style to the brick-built Georgian extension to the farmhouse. It is possible that by this period the barn was in need of repair, and the bricks were an obvious substitute for the timber infilling.

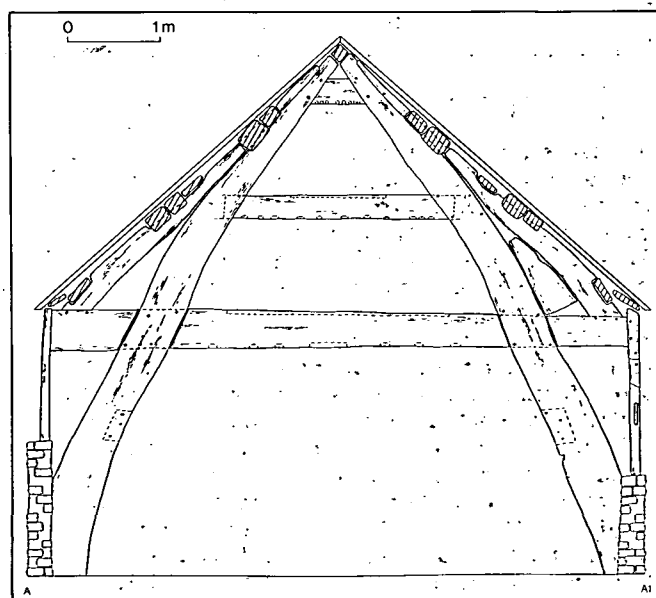
Fig 5 Seddons Fold : section A-A1

Truss A (Fig 5)

The purlin-beam and wall tie-beam both remain in position on this truss, and there is evidence for a

lower cross-beam and a single vertical beam having been present at one time. In addition, the wall tie-beam, cross-beam and collar-beam all display grooves for wattle panelling and wall-studs. This arrangement of timbers suggests that Bay A was, in some way, independent of the rest of the building. The truss has been carefully repaired with oak pegging where the wood has split, and the wall tie-beam bears the original carpenter's numbering '1 x 1'. A large wedge of wood has been inserted on the west side between the cruck and the outer blade, to support the weight of the latter. A feature common to all the trusses is that the wall-posts are morticed into the wall-plates.

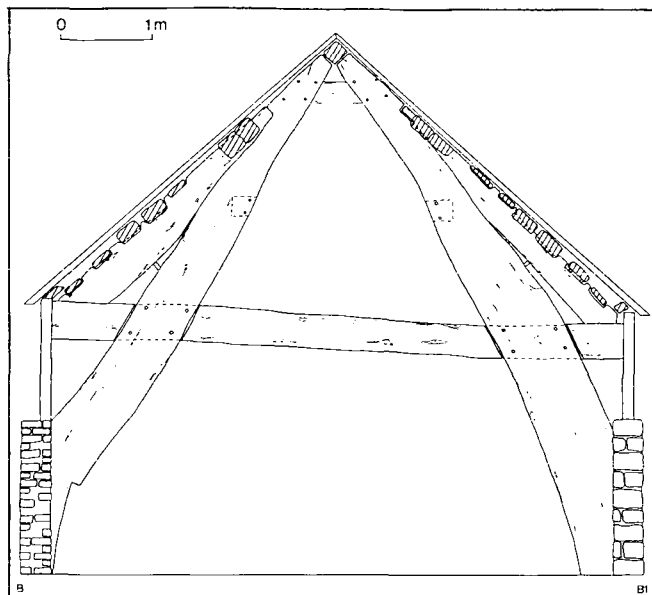
Fig 6 Seddons Fold : section B-B1

Truss B (Fig 6)

The cruck blade, outer blade and wall tie-beam have all been clearly marked by the carpenter with the

symbol \perp . Where marks have been identified, they all appear on the southern face of the timbers. This would imply that the timbers were marked up and put together with the eastern face downwards, before being brought to the site and erected. The purlin-beam is missing, though the pegging holding the outer blade in position is clearly visible.

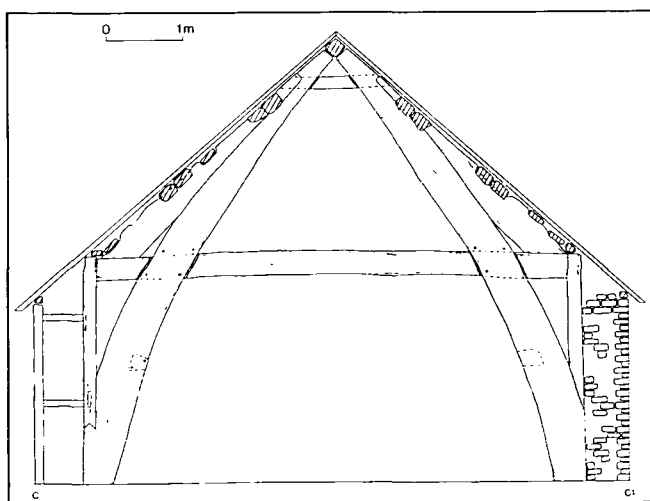
Fig 7 Seddons Fold : section C-C1

Truss C (Fig 7)

There is clear evidence on the cruck blade of a lower cross-beam having once been present, which may have supported an internal arrangement of timbers associated with Bay D. The way in which the wall-post has been set on the back of the cruck blade can clearly be seen on this truss, since the

lower timbers have not been encased in stone or brickwork.

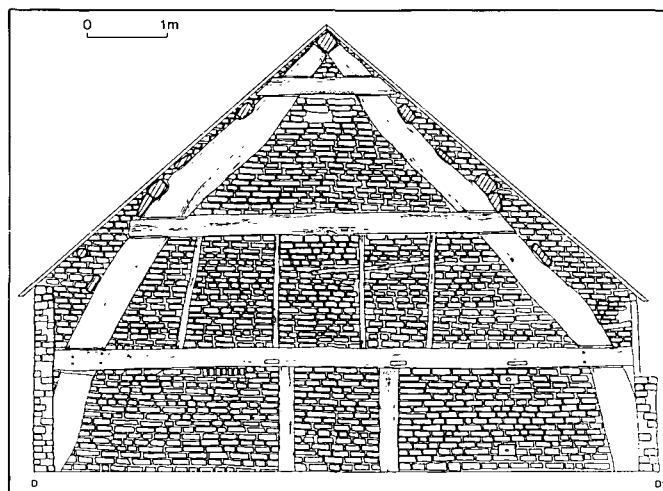
Fig 8 Seddons Fold : elevation D-D1

Truss D (Fig 8)

The arrangement of the timbers of this truss are completely different to those of A, B and C. It is considerably wider, the blades are far more curved, and the roof is set directly on the cruck blades, in the absence of outer blades. The timbers are entirely infilled with brickwork which must have replaced wattle panelling, since grooves are still visible on the collar-, purlin-, and wall tie-beam.
