A MEASURED SURVEY OF THE BUILDINGS AT NUMBERS 30A AND 31 MARKET PLACE, STOCKPORT

C Hartwell and SR Bryant

This measured survey of numbers 30a and 31 Market Place was carried out during the period January-June 1985. The survey was undertaken to provide a record of grade II listed buildings following an application for consent to demolish by the owner, Mr R Gardner.

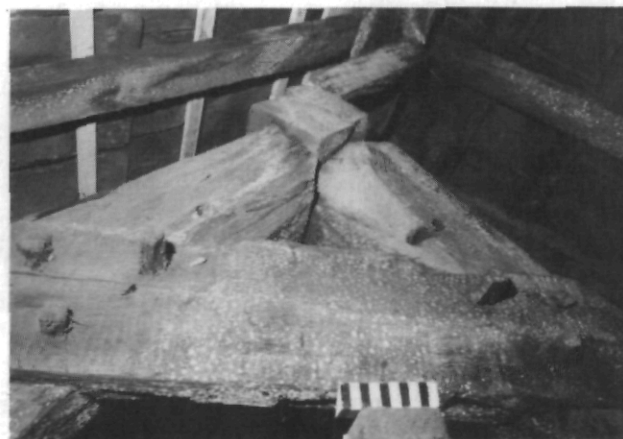
Plate 1 30a Market Place : apex of phase 1 cruck

The upper halves of two pairs of oak cruck blades survive. Of the eastern pair, part of the southern blade and the apex can be examined at first floor level, where the blades are held together by a collar and have a ridge set diagonally between them: Alcock's 'type A' apex (Alcock 1973, 10). The ridge between this and the central cruck truss has survived intact, and a small section of a purlin remains. This has been cut close to the blade and is joined to it by a simple lap joint. A short distance below is a tie-beam: a roughly-finished timber also joined by a lap joint. Staves and wattle-and-daub infill can be seen on the underside of the blade and the mount for a windbrace was observed just above present floor level. The wattle-and-daub infill and poorer quality of this cruck truss suggest that it formed an end wall to the building.

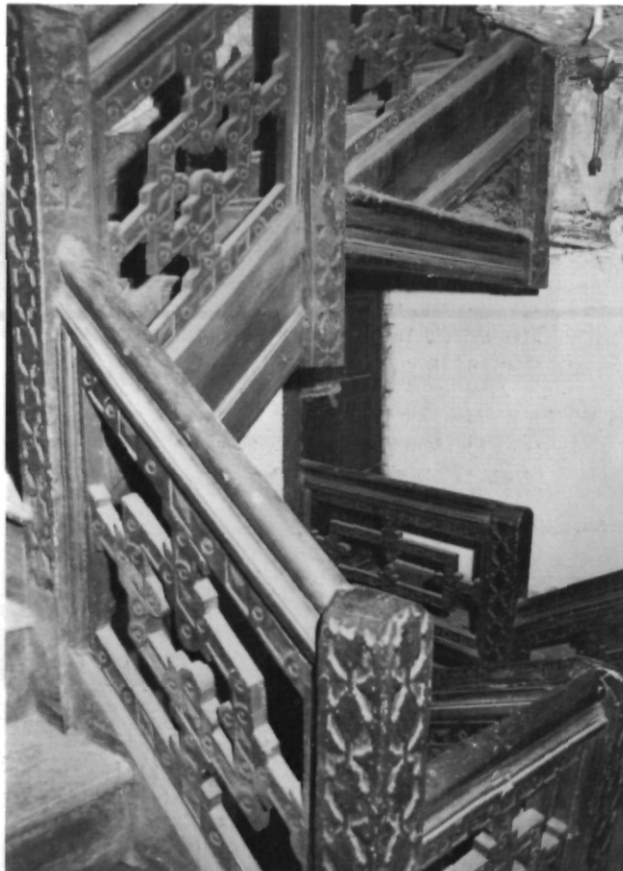
Plate 2 30a Market Place : the staircase

A cage newel staircase rises the full height of the building in A4. This was probably inserted at the same time as, or shortly after, the alterations described above, to give access to the newly-built upper floor of A5. Cage newel staircases are relatively rare to the North West, and this elaborately-carved and decorated example is unique in the county (Smith 1977, 17). Between the handrail and string are panels, perforated to form a pattern. These and the newel posts are decorated with strap-work designs (Plate 2).

The decorative features and staircase type suggest a date in the first half of the 17th century (Godfrey 1910, 36; Jourdain 1950, 24-5), but exact parallels are hard to find. Cage newel staircases, in the main dating to the first quarter of the century, are cited by Godfrey (1910, 35) and by Smith (1977, 17), whilst similar decorative techniques exist at Clare College, Cambridge (RCHME 1959, plate 66) which is dated 1640-42, and at Aston Hall, Birmingham (Mercer 1962, Plate 40a) which is dated 1618-35.

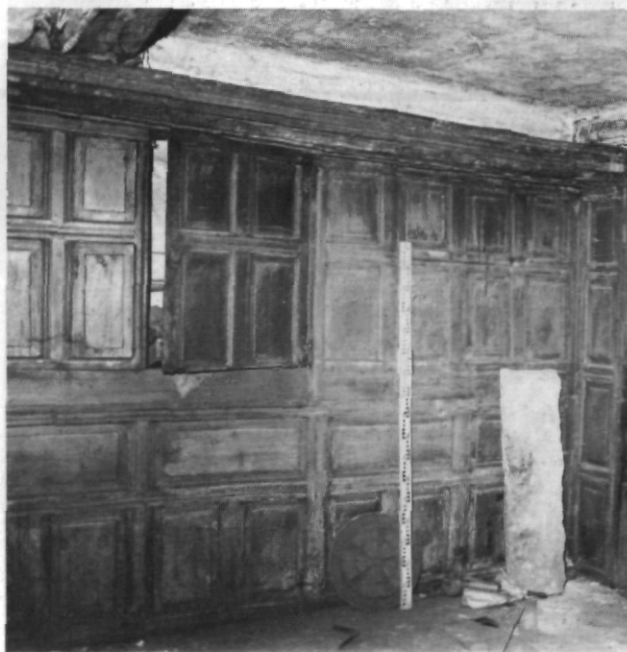
Plate 3 30a Market Place : early 17th century panelling

The first floor room of A5 is panelled in oak. Since the east wall is panelled to ceiling height it is likely that the door and window in the eastern elevation were blocked before, or at the time of, the insertion of the panelling. The latter consists of small rectangular panels, framed in narrow stiles with fine moulding (Plate 3). These features, and the absence of a dado or skirting, suggest an early 17th century date (Jourdain 1950, 15-17; Cunnington 1980, 170-3). A similar example can be seen in the Black Swan, York (RCHME 1981, plate 170), dated to the early 17th century. All except the north wall are panelled to ceiling height. In the west wall panelling continues flush with the chimney breast, thus acting as a partition for two small rooms on either side of the chimney. The north wall is half-panelled.

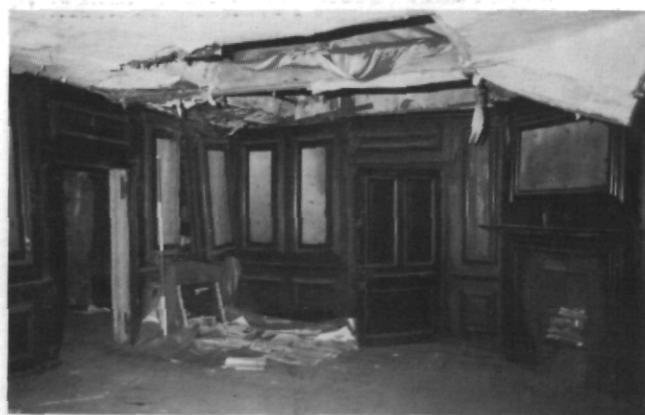
Plate 4 30a Market Place : late 17th-early 18th century panelling

The rooms of A1 and A2 were oak-panelled in a style suggesting a late 17th or early 18th century date (Jourdain 1950, 37; Cunnington 1980, 170-3). Large rectangular panels with bolection moulding are arranged vertically above a dado of smaller panels set horizontally, and the stiles and rails are richly moulded (Plate 4). The panelling closely resembles that which can be seen in the Great House, Llanmaes, which is dated c1700 (RCHMW 1981
